Wolf Creek dam foundation remediation an innovative solution

F. Santillan, Treviicos, USA

A complex and innovative remediation programme is currently being undertaken by USACE at the Wolf Creek multipurpose dam in the USA, where problems had been caused by the karstic foundations. After an evaluation of several alternatives to deal with seepage, it was decided to construct a concrete diaphragm wall.

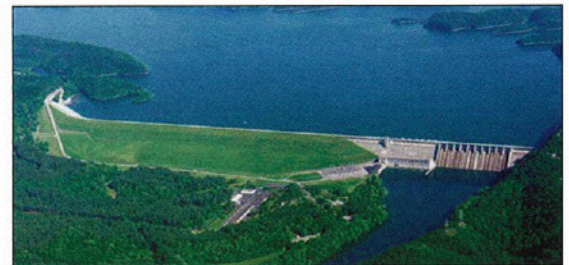
(b) General view of the Wolf Creek dam.

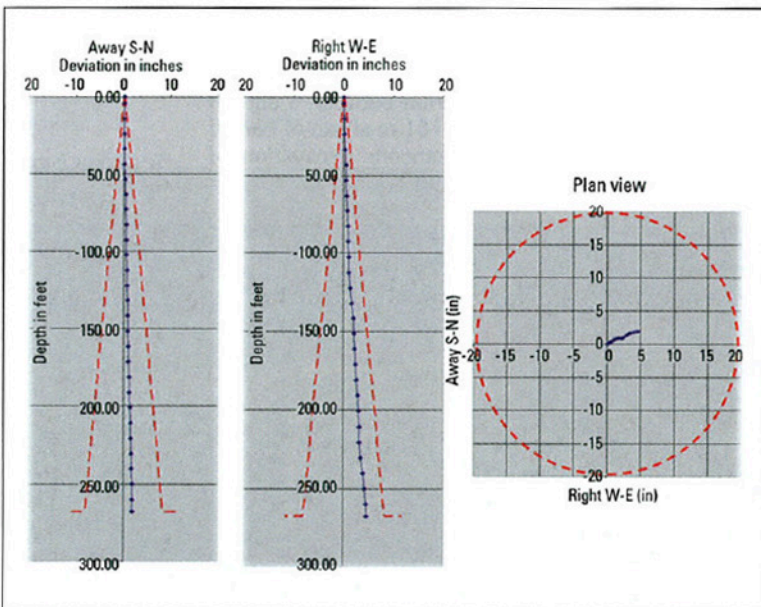
Fig. 5. Directional drilling deviation charts.

The execution of the DD pilot holes evolved during the project from the original target maximum deviation of 21 cm at 86 m, to a significantly improved 5-7 cm at the same depth for more than 60 per cent of the elements installed. This achievement is unprecedented for this scenario.

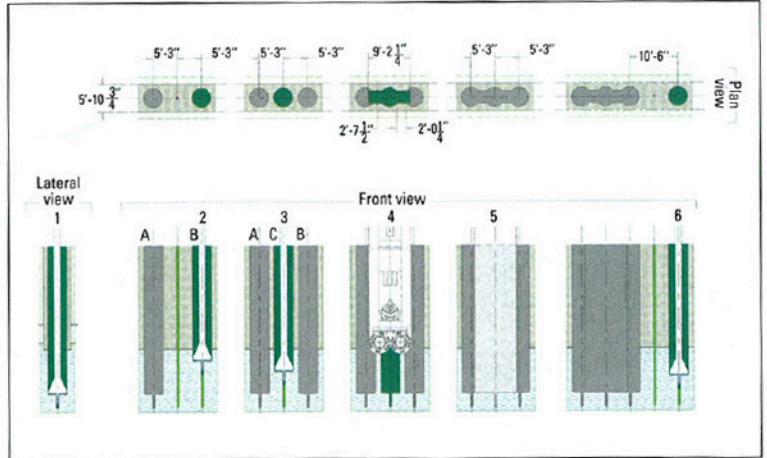
Fig. 8. Typical installation sequence for the combined barrier wall method, showing: (1) reverse circulation drilling dia. 50' in (1270 mm) down to specified depth; (2) after concrete maturity of Shaft A, execute Shaft B; (3) after maturity of Shaft B, drill Shaft C and pout concrete into shaft if required; (4) excavate with Hydromill a middle-connecting element, 2.62 in (800 mm) wide, down to design depths; (5) pour concrete into open excavation using the tremie method; and, (6) continue production of the compound wall with the same sequence.

In some areas of the barrier wall, another construction method was utilized. This method is called Combined Barrier Wall Method (CBWM) and involves the combination of RCD piles and hydromill excavated panels.

The advantage of this method is that the footprint of five secant piles can be covered with two 127 cm RCD piles and one 2.8 m hydromill panel, thus using less material and building fewer joints between elements. Where the strength of the rock surpasses 206.8 MPa, and the depth of the panels exceeds 61 m, the utilization of this method would be successful but has to be weighed against time and cost considerations.

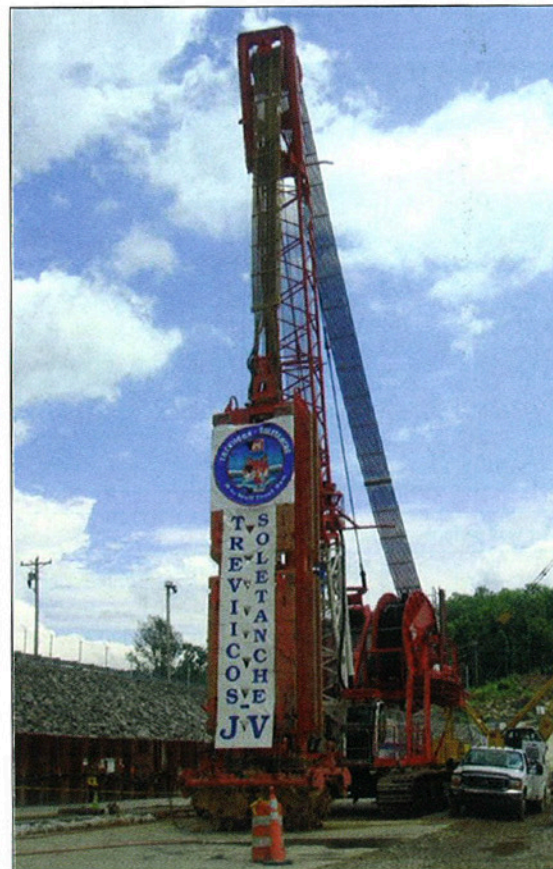
(d) Hydromill set up to work on the CBWM.

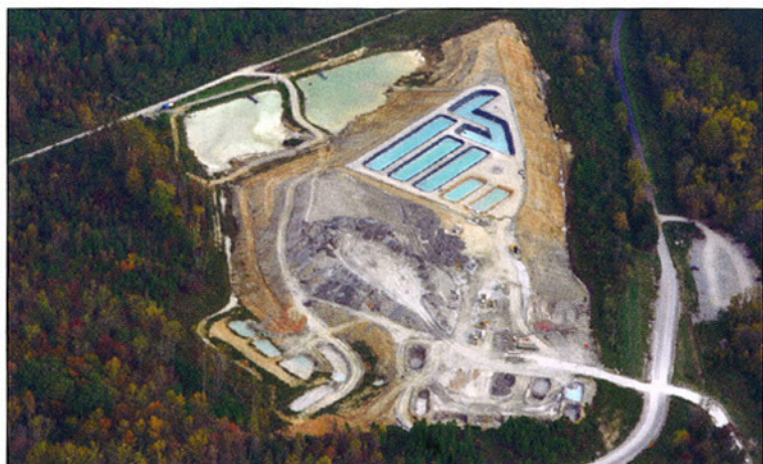
(e) The disposal area.

In addition, the disposal of waste and water constitutes a project within the project. TSJV has been able to set up a system, which allows the treatment and disposal of 1.1×10^6 litres of water per week and 2293 m³ of solid waste.

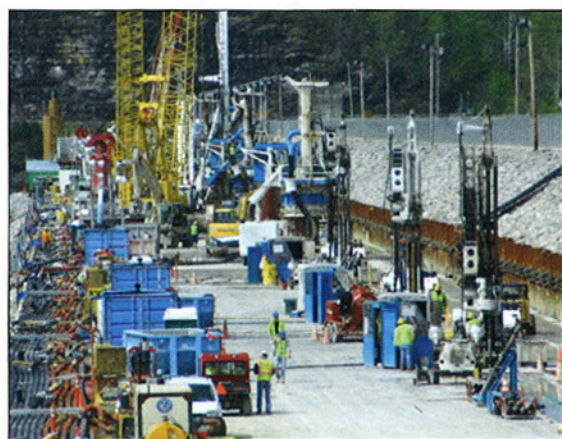
(f) Three directional drilling rigs installing pilot holes in non-critical areas.
