ARMY CORPS TAKES ANOTHER CRACK AT SEALING WOLF CREEK DAM'S SEEPING FOUNDATION

# OUT OF SIGHT, OUT OF MIND

Visible portions of Kentucky's hydroelectric Wolf Creek Dam are in top shape, but foundation flaws make the dam a high-risk priority By Luke Abaffy

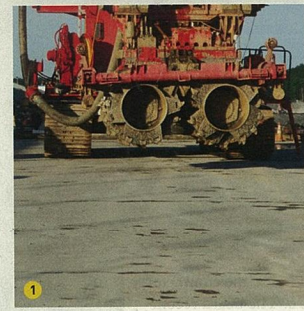
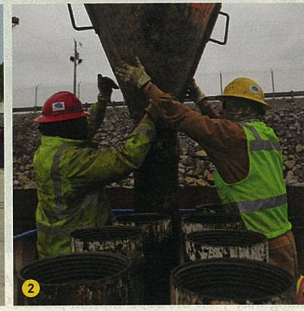
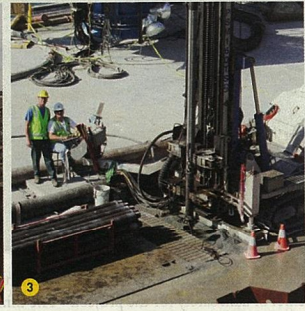
**Barrier Wall Design Methods: Secant Pile Method Is Used on 88% of the Wall**

**CONSTRUCTION SEQUENCE**  
After grout curtains and a concrete work slab are in place, (1) the slurry-submerged hydromill eats down 2 ft into foundation rock through the clay embankment and seating; (2) concrete is poured through pipes into the slurry, forming the permanent concrete embankment wall (PCEW); (3) the PCEW lends grip and stability to 8-in. pilot holes that come within a 5-in. accuracy range, guiding pile placement.

Two wall designs are used. The first is a series of 50-in. overlapping secant piles. The second is a combination wall comprising rectangular panels tied together by secant piles. "The combination wall was originally intended for 70% of the job," says Haskins. "It's now being used for 12% of the wall."
