Trevi reveals Mosul Dam repair strategy

12 May, 2016 By Emily Ashwell

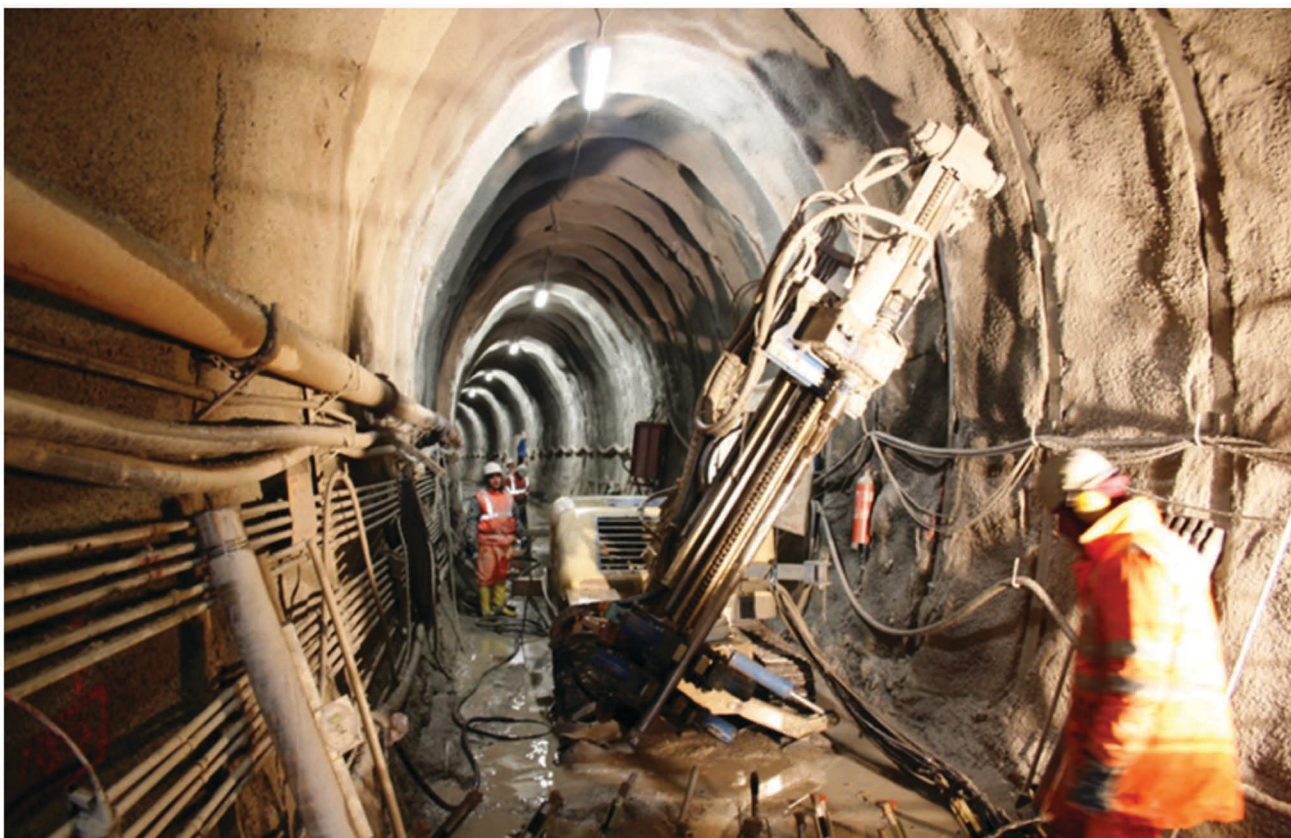
The Soilmec SM-5E will be used by Trevi in the Mosul Dam repairs. This image shows it in use in Italy.

Trevi said the repairs will be carried out both from the grouting gallery and dam crest. In the small gallery, 3.7m-high and 3m-wide Soilmec SM-5 rigs will be used. The work will cover three areas, totalling 500m. On the dam crest, surface interventions will be carried out using Soilmec SM-16 rigs with long stroke, for 420m towards the west of the spillway, and from the crest of the dam along the eastern wall of the spillway for 700m.
